**1234 Main Dr.  
Hometown, Texas**

**THIS PRE DRYWALL INSPECTION REPORT WAS PREPARED FOR**

**MR. & MRS. JAMES SMITH**

## PROPERTY INSPECTION REPORT

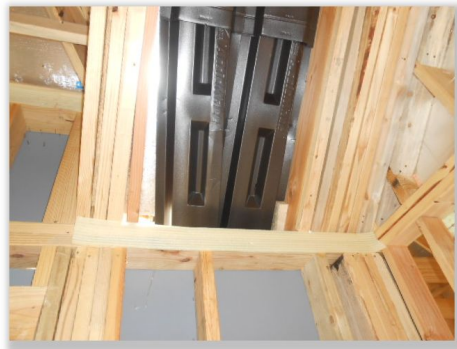
**Soffit venting & baffles were installed at the stage of this inspection.**

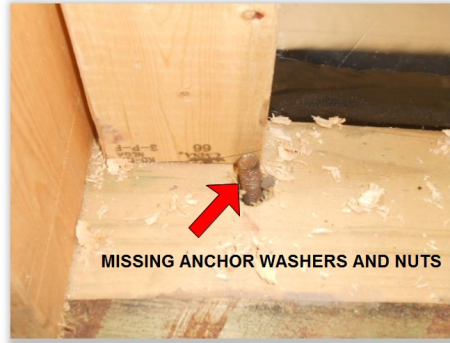
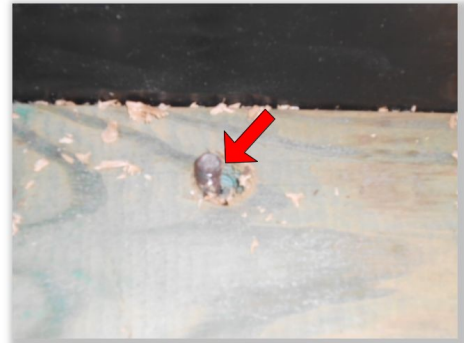
**Several of the anchor bolts on the south and west exterior wall plates were missing washers & nuts.**
